PRIMARY RECORD

* Resource Name or #: 13040 Del Monte Drive/Building 45/Leisure World

State of California & The Resources Agency
DEPARTMENT OF PARKS AND RECREATION
DISTRICT RECORD

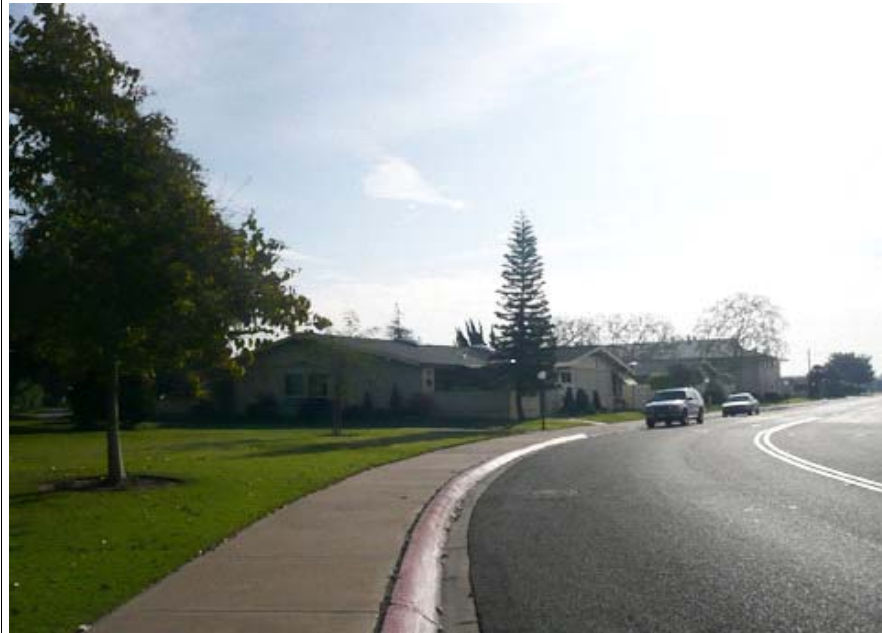
Facing west; Photo No. P1030778.jpg;

* P3a. Description: (Describe resource and its major elements. Include design, materials, condition, alterations, size, setting, and boundaries.)
The one-story Ranch style building is square in plan. The cross gabled roof, with boxed eaves and false beams, is clad in composition shingles. Its is not known if the bubble skylights are original to the building. Most of the windows have been replaced with vinyl fixed pane and sliding units. Each residential unit is accessed via a courtyard that is enclosed with a concrete block and screening block wall.

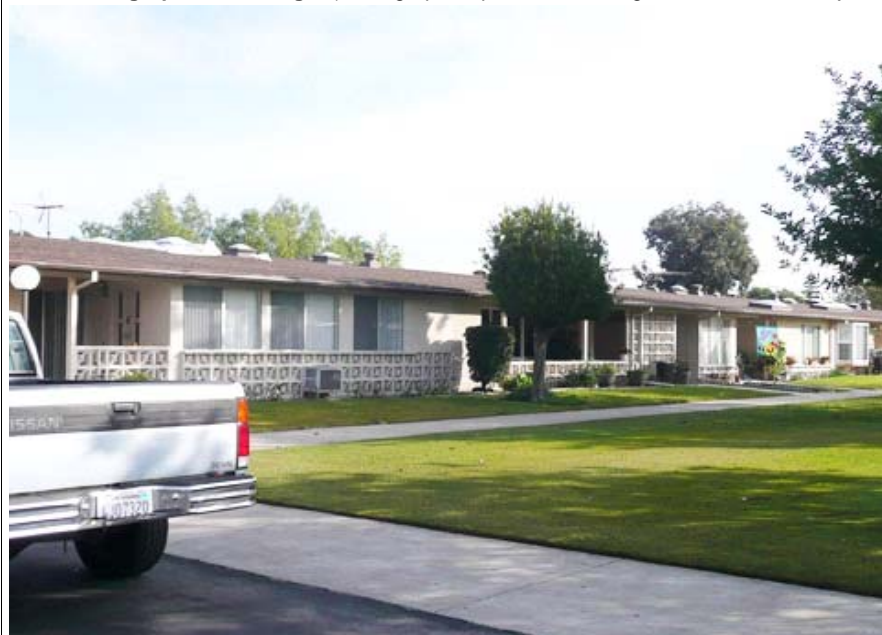
Facing northwest; 1/26/2010; Photo No.
P1030775.jpg

* P3a. Description: (Describe resource and its major elements. Include design, materials, condition, alterations, size, setting, and boundaries.)
The one-story building is rectangular in plan. The side gabled roof is clad in composition shingles. It is not known if the bubble skylights are original to the building. The exterior walls are clad in smooth textured stucco. The aluminum sliding windows appear to be original, and a minority of the windows have been replaced with vinyl sash units. The primary entrances for the units are at grade and are accessed via cast concrete porches which are partially enclosed with concrete screening block. The building is a contributor to the Leisure World National Register of Historic Places-eligible historic district.

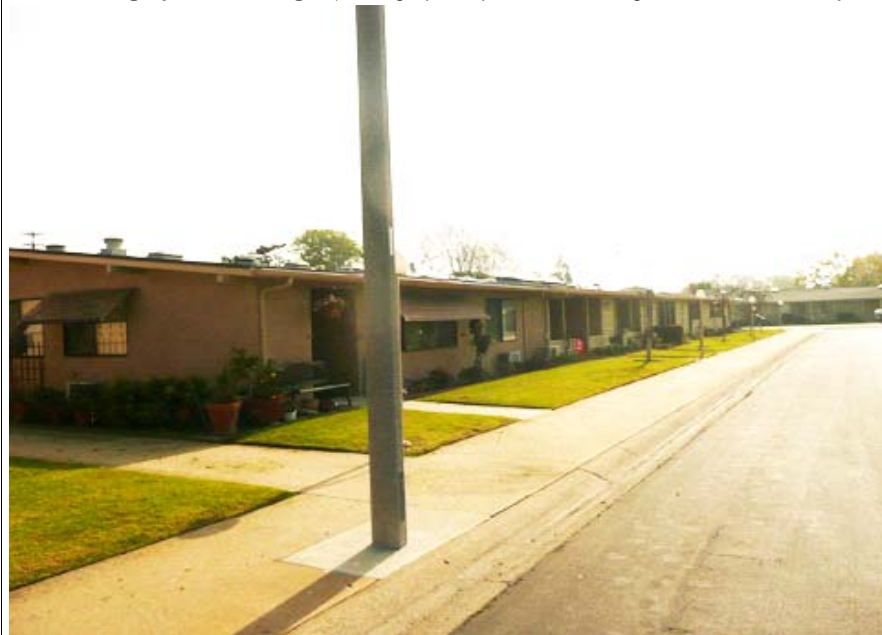
Facing southeast; 2/18/2010; Photo No.
P1030909.jpg

* P3a. Description: (Describe resource and its major elements. Include design, materials, condition, alterations, size, setting, and boundaries.)
The one-story Ranch style building is rectangular in plan. The side gabled roof is clad in composition shingles, and it is not known if the bubble skylights are original. The exterior walls are clad in smooth textured stucco. The aluminum sliding windows appear to be original. Each residential unit is accessed via a porch, with is partially enclosed with a concrete screening block wall. The building is a contributor to the Leisure World National Register of Historic Places-eligible historic district. The building is a contributor to the Leisure World National Register of Historic Places-eligible historic district.

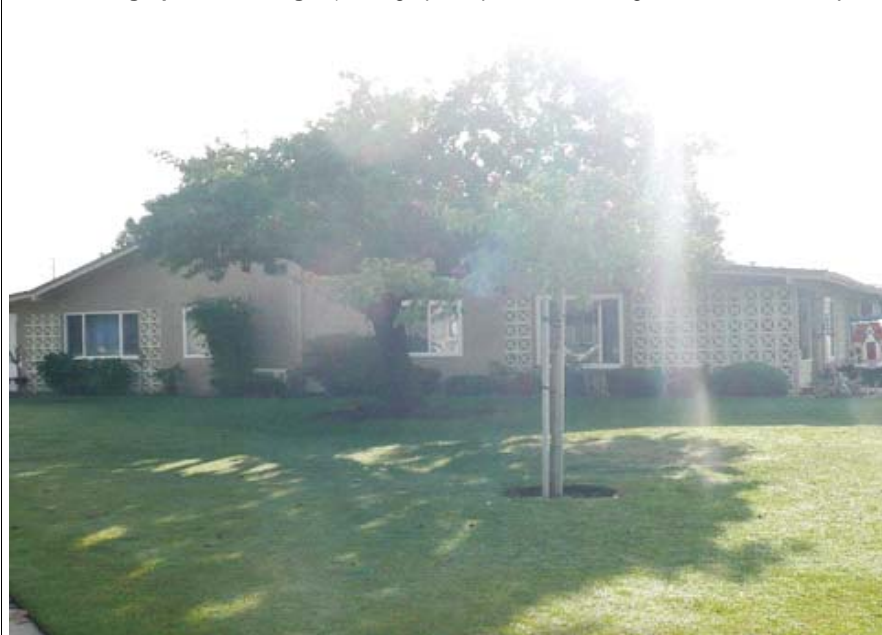
Facing south southwest; Photo No.

* P3a. Description: (Describe resource and its major elements. Include design, materials, condition, alterations, size, setting, and boundaries.)
The one-story building is rectangular in plan. The side gabled roof is clad in composition shingles. It is not known if the bubble skylights are original to the building. The exterior walls are clad in smooth textured stucco. The aluminum sliding windows appear to be original, but the majority of the windows have been replaced with vinyl sash units. The primary entrances for the units are at grade and are accessed via cast concrete porches which are partially enclosed with concrete screening block. The building is a contributor to the Leisure World National Register of Historic Places-eligible historic district.

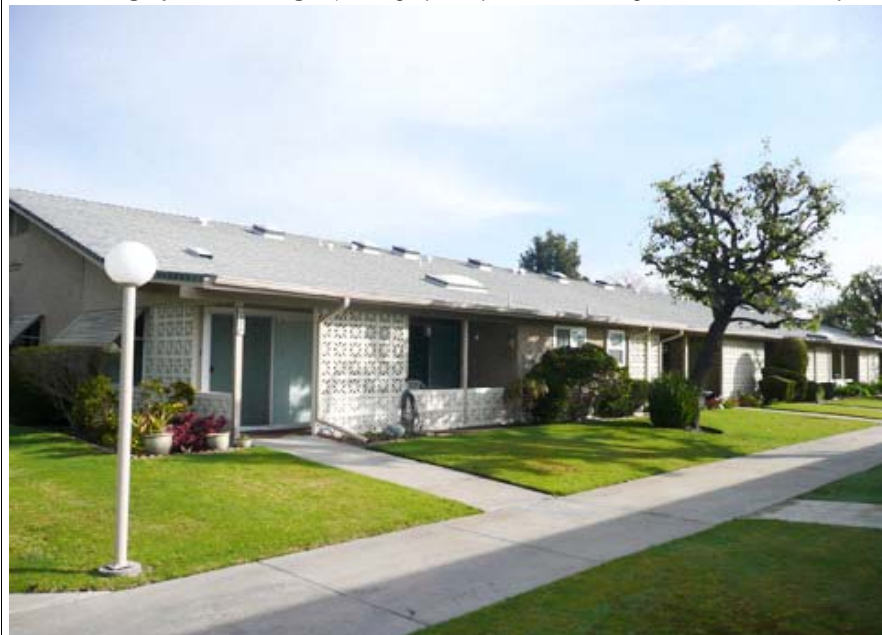
Facing west northwest; Photo No.

* P3a. Description: (Describe resource and its major elements. Include design, materials, condition, alterations, size, setting, and boundaries.)
The one-story building is rectangular in plan. The side gabled roof is clad in composition shingles. It is not known if the bubble skylights are original to the building. The exterior walls are clad in smooth textured stucco. The aluminum sliding windows appear to be original, and a minority of the windows have been replaced with vinyl sash units. The primary entrances for the units are at grade and are accessed via cast concrete porches which are partially enclosed with concrete screening block. The building is a contributor to the Leisure World National Register of Historic Places-eligible historic district.

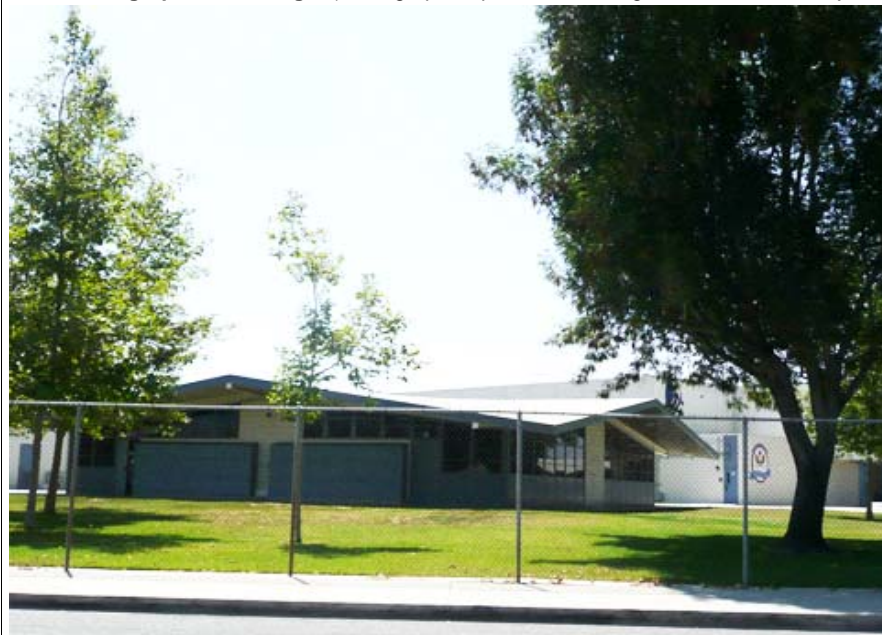
Facing west; 6/15/2010; Photo No.

* P3a. Description: (Describe resource and its major elements. Include design, materials, condition, alterations, size, setting, and boundaries.)
The school campus consists of nine one-story classroom buildings and one one-story auditorium building which form a circle around a central one-story administrative building and gymnasium. The classroom buildings appear to be identical in design. Each building is square in plan, with a cross gabled roof with false beams at the gable heads, concrete block veneer and ribbons of fixed-pane windows are accented with spandrel panels. The auditorium is hour-glass shaped, clad in concrete block with minimal window openings, and is accented with outdoor amphitheatre seating. It appears one modern portable building is located on the west end of the campus.

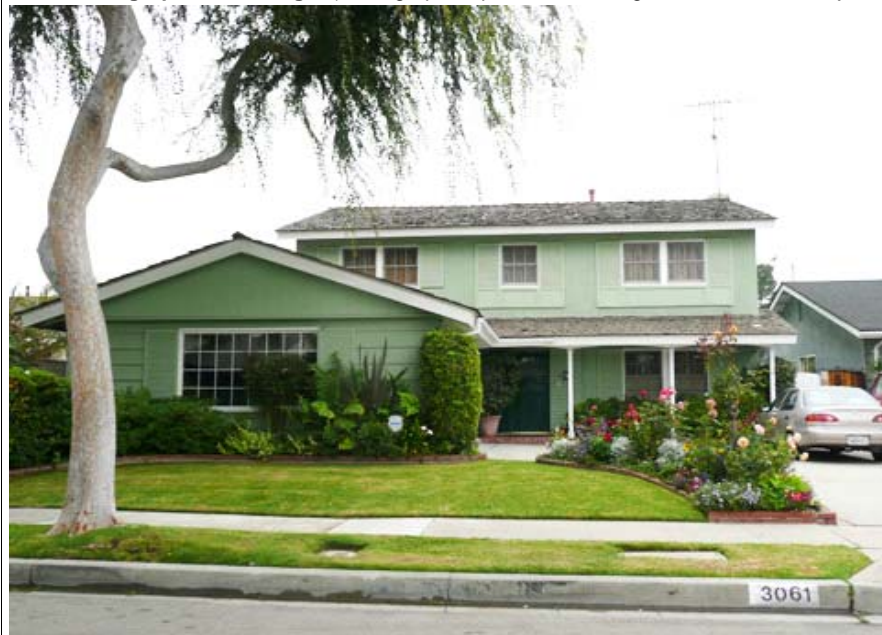
* P3a. Description: (Describe resource and its major elements. Include design, materials, condition, alterations, size, setting, and boundaries.)
Of the 35 parcels of Tract 3995 that are located within the APE, twenty contained buildings with sufficient integrity to warrant further investigation, which resulted in the subdivision retaining 57 percent integrity. None of the twenty buildings appear to possess sufficient architectural quality for the reasons identified in the district record to be considered eligible for listing in the NRHP or the CRHR as individual historic resources or as a historic district.

View of a common Ranch style found in this district.

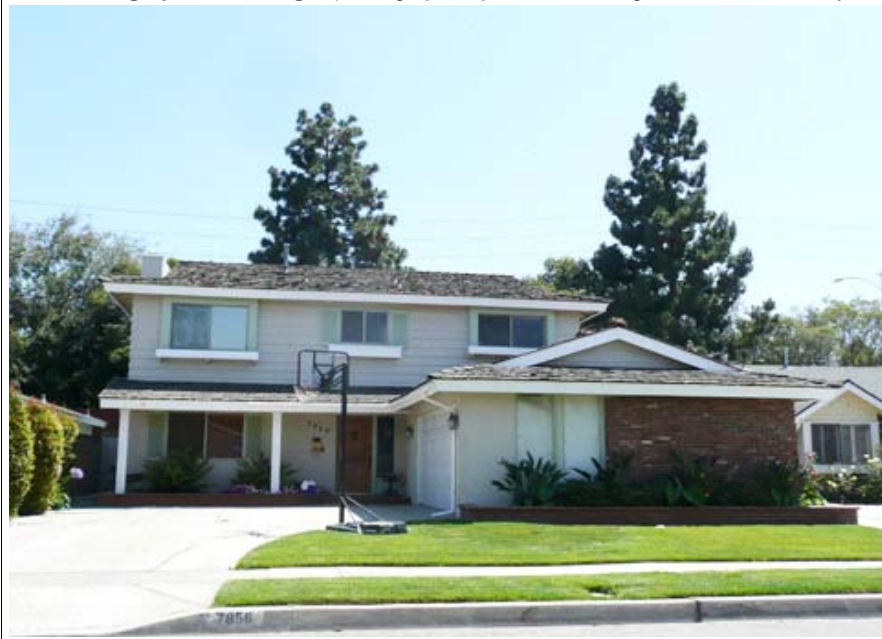
Facing south; 6/24/2010; Photo No.

* P3a. Description: (Describe resource and its major elements. Include design, materials, condition, alterations, size, setting, and boundaries.)
The two-story Ranch style building is 'L'-shaped in plan. The gable on hip roof is clad in wood shingles. A brick chimney is located on the eastern façade of the building. The exterior walls are clad in smooth stucco on the ground floor, and horizontal wood siding on the second floor. The aluminum sliding windows appear to be original, are accented with shutters, and the windows on the second floor are further accented with flower boxes. The primary entrance is accessed via a covered porch which spans the primary (northern) façade. The pent roof which shelters the porch is supported by square wood posts. The wood with sidelight primary entrance appears to be original. An attached two-car garage projects from the western end of the primary (northern) façade. The garage is clad in smooth textured stucco and brick veneer. Fenestration on the garage consists of two fixed-pane windows which create an off center vertical band. Landscaping includes brick planters. The building does not meet the NRHP and CRHR eligibility criteria for the reasons identified on the district record prepared for this subdivision; therefore the building does not contribute to a historic district and is not individually eligible for listing in the NRHP and the CRHR.

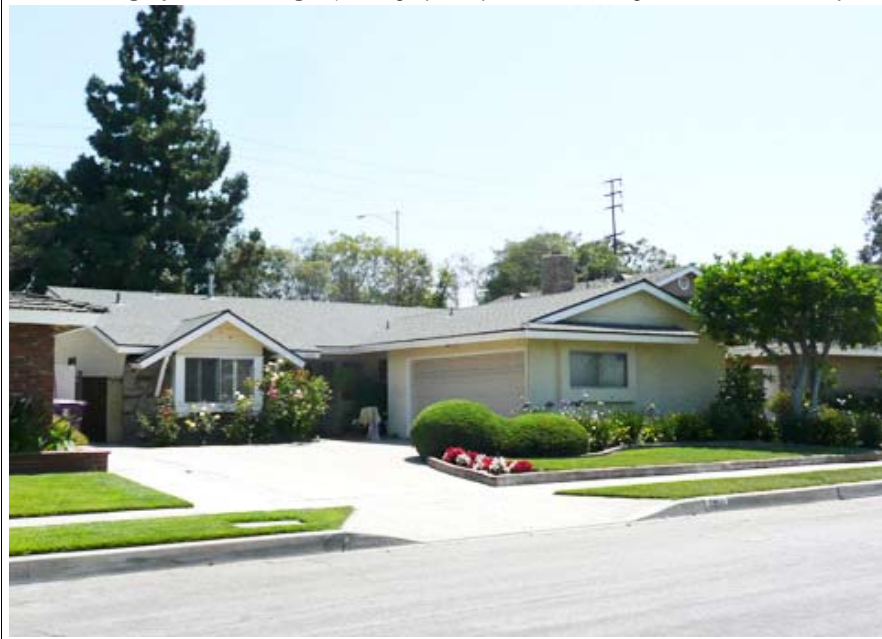
Facing south; 6/24/2010; Photo No.

* P3a. Description: (Describe resource and its major elements. Include design, materials, condition, alterations, size, setting, and boundaries.)
The one-story Ranch style building is 'L'-shaped in plan. The cross gable on hip roof is clad in composition shingles. The gable on the eastern end of the primary (northern) façade is accented with triangulated knee brackets and a doveote. The exterior walls are clad in textured stucco, stone veneer, and horizontal wood siding. The aluminum sliding windows appear to be original. The primary entrance is recessed and at grade. An attached two-car garage projects from the western end of the primary (northern) façade. A pent roof partially spans the northern end of the garage. Landscaping includes low brick retaining walls, and a concrete block and screening block wall demarcates the front and rear yards. The building does not meet the NRHP and CRHR eligibility criteria for the reasons identified on the district record prepared for this subdivision; therefore the building does not contribute to a historic district and is not individually eligible for listing in the NRHP and the CRHR.

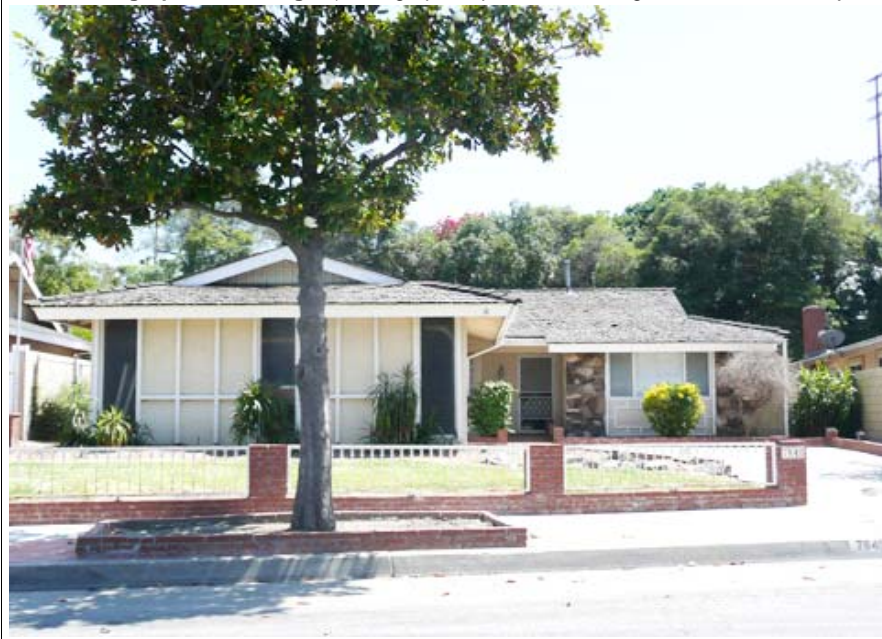
Facing south; 6/24/2010; Photo No.

* P3a. Description: (Describe resource and its major elements. Include design, materials, condition, alterations, size, setting, and boundaries.)
The one-story Ranch style building is 'L'-shaped in plan. The cross gable on hip roof is clad in wood shingles. The gables are accented with lattice. The exterior walls are clad in textured stucco accented with geometric-patterned false timbering, and stone veneer. The windows were replaced with vinyl fixed-pane and casement units at an unknown date. The primary entrance is recessed and at grade. An attached two-car garage projects from the eastern end of the primary (northern) façade. Three vertical bands of fixed-pane pebble glass windows and false timbering accent the northern façade of the garage. Landscaping includes brick planters and a brick and metal perimeter fence encloses the front yard. The building does not meet the NRHP and CRHR eligibility criteria for the reasons identified on the district record prepared for this subdivision; therefore the building does not contribute to a historic district and is not individually eligible for listing in the NRHP and the CRHR.

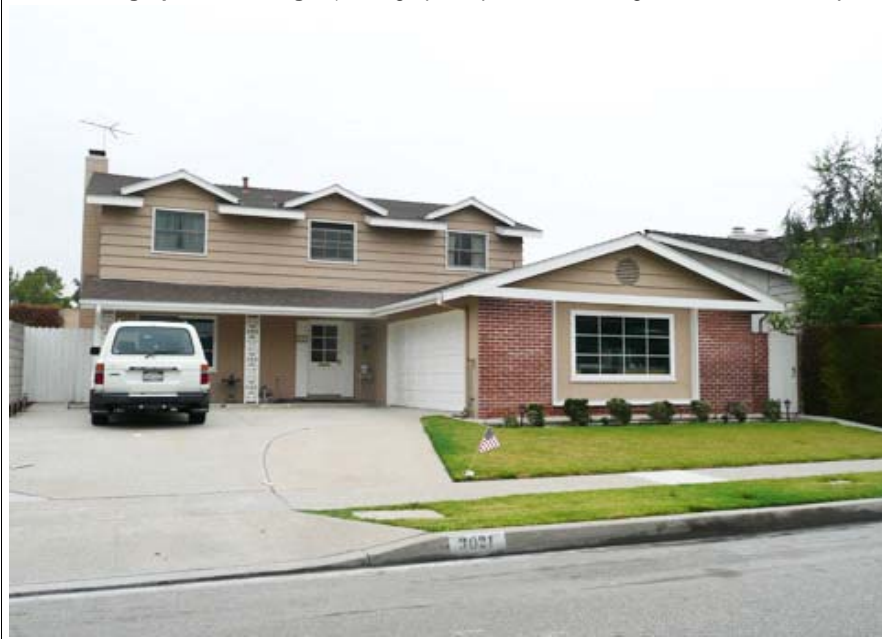
Facing west; 7/8/2010; Photo No.

* P3a. Description: (Describe resource and its major elements. Include design, materials, condition, alterations, size, setting, and boundaries.)
The two-story Ranch style building is 'L'-shaped in plan. The cross gabled roof, with boxed eaves, is clad in composition shingles. A brick chimney is located on the southern façade. The second floor and eastern gable are clad in horizontal wood siding, the ground floor of the building is clad in smooth textured stucco, and the southern façade of the one-story garage is clad in brick veneer. The six-over-six wood sash and 3-paned sliding wood window appear to be original. The fixed-pane window on the south elevation has been replaced with a vinyl unit. The primary entrance is raised, and accessed via a cast concrete porch which spans the southern bay of the primary (eastern) façade. Decorative metal columns support the porch roof. The primary entrance consists of a wood with glazing door flanked by fluted pilasters. The building does not meet the NRHP and CRHR eligibility criteria for the reasons identified on the district record prepared for this subdivision; therefore the building does not contribute to a historic district and is not individually eligible for listing in the NRHP and the CRHR.

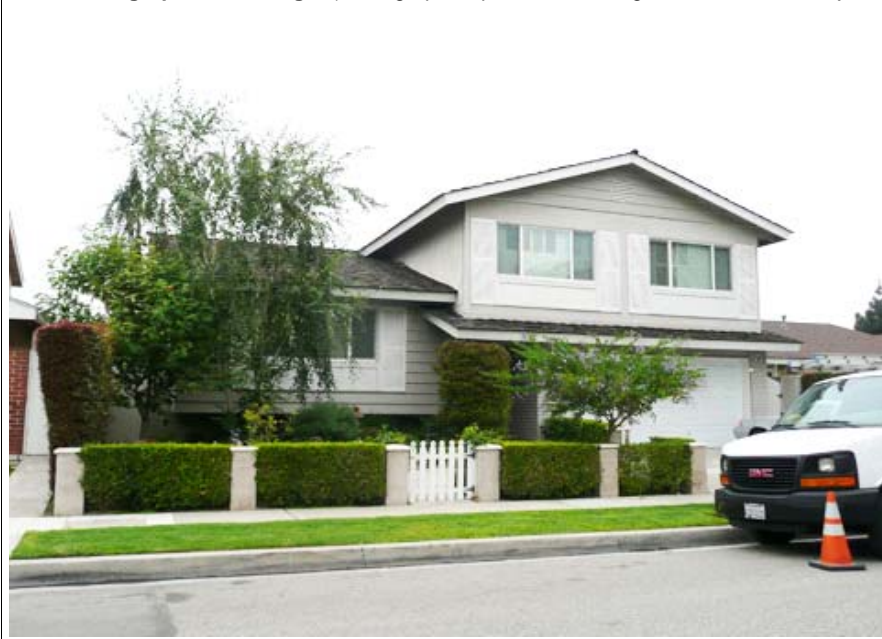
Facing west; 7/8/2010; Photo No.

* P3a. Description: (Describe resource and its major elements. Include design, materials, condition, alterations, size, setting, and boundaries.)
The 1 1/2-story Ranch style building is 'L'-shaped in plan. The cross gabled roof is clad in wood shingles. The exterior walls are clad in textured stucco, which may be a secondary coating, and the front-facing gable and projecting bay on the southern end of the primary (eastern) façade are clad in horizontal wood siding. The aluminum sliding and fixed-pane windows appear to be original, and are accented with shutters and spandrel panels. The attached two-car garage, with roll-up door, is accented with brick veneer. The building does not meet the NRHP and CRHR eligibility criteria for the reasons identified on the district record prepared for this subdivision; therefore the building does not contribute to a historic district and is not individually eligible for listing in the NRHP and the CRHR.

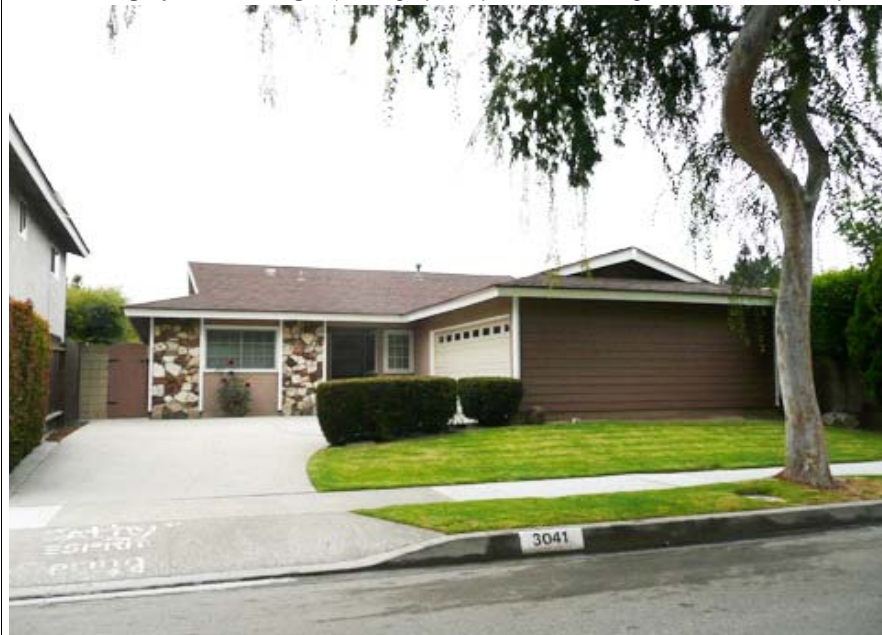
Facing west; 7/8/2010; Photo No.

* P3a. Description: (Describe resource and its major elements. Include design, materials, condition, alterations, size, setting, and boundaries.)
The one-story Ranch style building is 'L'-shaped in plan. The cross gable on hip roof, with boxed eaves, is clad in composition shingles. The gables are accented with false beams. The exterior walls are clad in textured stucco with corner boards, which is accented with stone veneer on the southern bay of the primary (eastern) façade. The windows have been replaced with vinyl sliding units, and are accented with wood surrounds. The primary entrance is recessed and is at grade. An attached two-car garage, with roll-up door, projects from the northern end of the primary (eastern) façade. The eastern façade of the garage is clad in horizontal wood siding. The building does not meet the NRHP and CRHR eligibility criteria for the reasons identified on the district record prepared for this subdivision; therefore the building does not contribute to a historic district and is not individually eligible for listing in the NRHP and the CRHR.

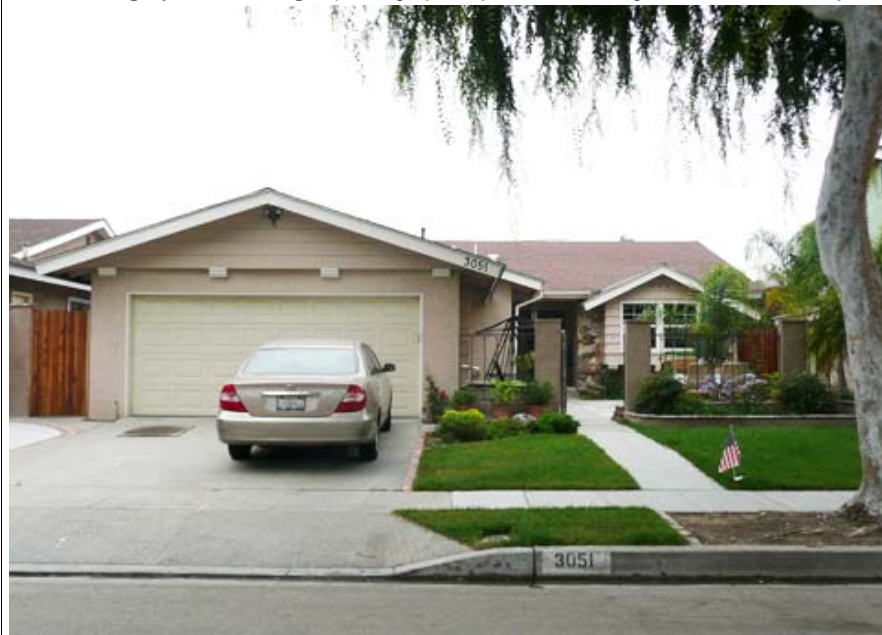
Facing west; 7/8/2010; Photo No.

* P3a. Description: (Describe resource and its major elements. Include design, materials, condition, alterations, size, setting, and boundaries.)
The one-story Ranch style building is 'L'-shaped in plan. The cross gabled roof, with boxed eaves, is clad in composition shingles. The exterior walls are clad in smooth textured stucco, and the projecting bays are clad in horizontal wood siding. The northern gable on the primary (eastern) façade is asymmetrical, and accented with a dovetail and corbels at its base. The gable of the projecting garage, which is located at the southern end of the primary (eastern) façade is accented with horizontal wood siding and corbels. The windows have been replaced with vinyl sash units. The primary entrance is raised, recessed, and accessed via a cast concrete porch. The walls which form the entry porch are accented with stone veneer. A fence made of concrete block piers and metal partially encloses the yard. The building does not meet the NRHP and CRHR eligibility criteria for the reasons identified on the district record prepared for this subdivision; therefore the building does not contribute to a historic district and is not individually eligible for listing in the NRHP and the CRHR.

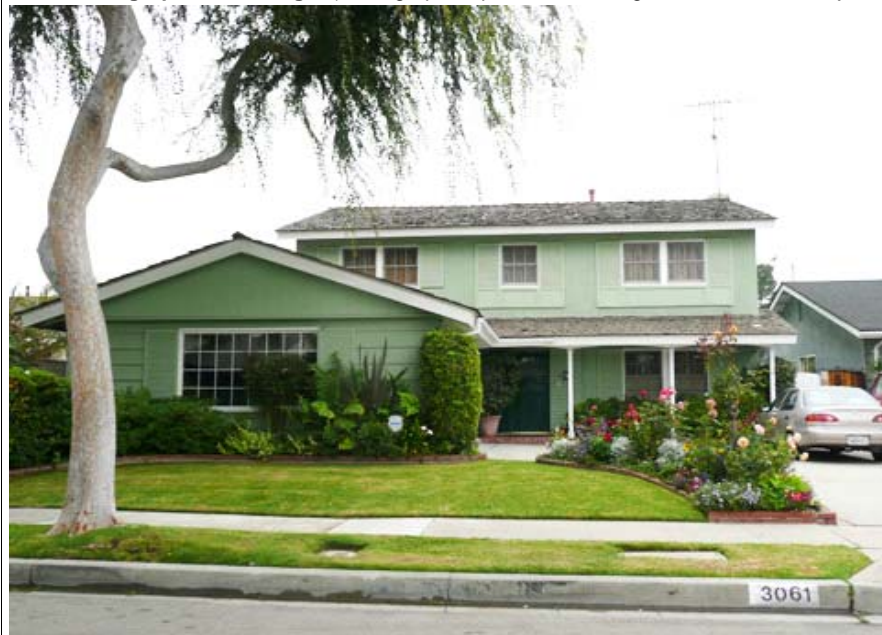
Facing west; 7/8/2010; Photo No.

* P3a. Description: (Describe resource and its major elements. Include design, materials, condition, alterations, size, setting, and boundaries.)
The two-story Ranch style building is 'L'-shaped in plan. The side and cross gabled roofs are clad in wood shingles. The exterior walls are clad in smooth textured stucco, and the one-story garage is clad in horizontal wood siding with vertical wood siding in the gable. The three-over-three wood sash windows appear to be original, and are accented with shutters and spandrel panels. The window on the east façade of the garage has been replaced with a fixed-pane vinyl unit. The primary entrance is raised, accessed via a covered porch which spans the northern bay of the primary (eastern) façade, and is accented with brick veneer. The double-acting primary entry doors appear to be modern. Square columns with simple capitals support the porch roof which spans the northern bay of the primary (eastern) façade. The building does not meet the NRHP and CRHR eligibility criteria for the reasons identified on the district record prepared for this subdivision; therefore the building does not contribute to a historic district and is not individually eligible for listing in the NRHP and the CRHR.

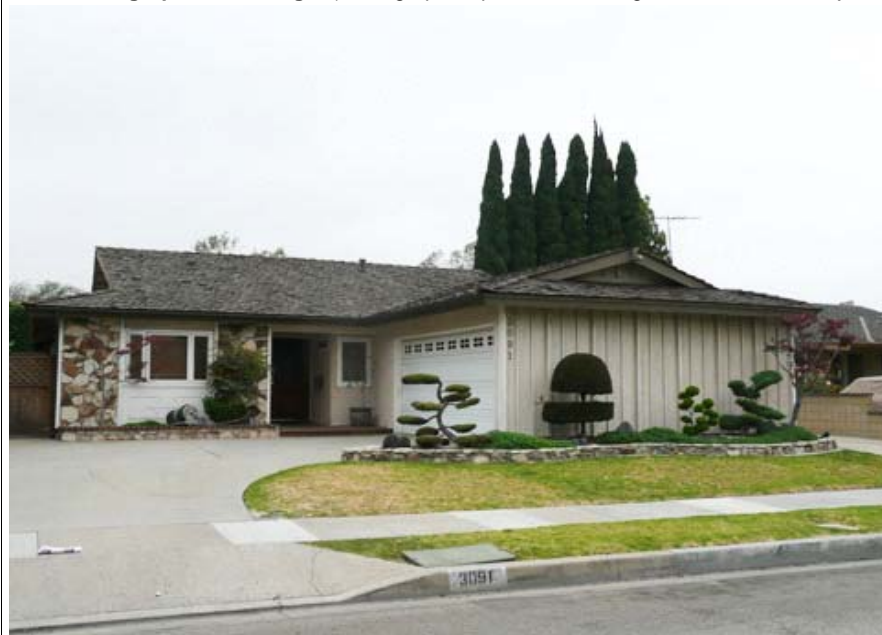
Facing west; 7/8/2010; Photo No.

* P3a. Description: (Describe resource and its major elements. Include design, materials, condition, alterations, size, setting, and boundaries.)
The one-story Ranch style building is 'L'-shaped in plan. The cross gable on hipped roof is clad in wood shingles. The easterly gable is accented with decorative false beams. The exterior walls are clad in smooth textured stucco and are accented with corner boards. The southern bay of the primary (eastern) façade is accented with stone veneer, and the eastern façade of the projecting garage bay is clad in vertical board and batten siding. The windows have been replaced with vinyl casement and fixed-pane units. The window on the southern bay of the primary (eastern) façade is accented with a spandrel panel with geometric detailing. The primary entrance is raised, recessed, and accessed via a brick-clad porch. The building does not meet the NRHP and CRHR eligibility criteria for the reasons identified on the district record prepared for this subdivision; therefore the building does not contribute to a historic district and is not individually eligible for listing in the NRHP and the CRHR. Landscaping includes stone planters and topiaries.

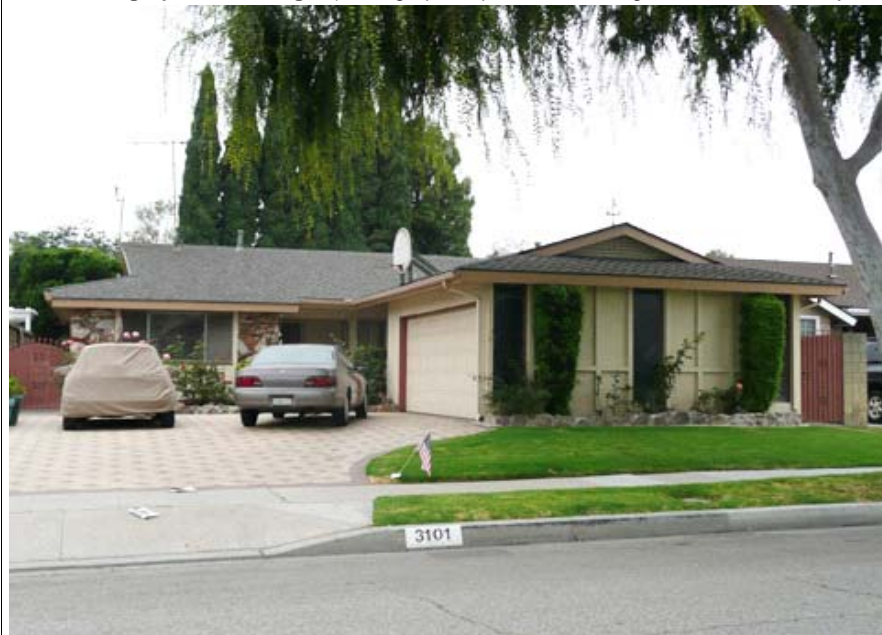
Facing west; 7/8/2010/ Photo No.

* P3a. Description: (Describe resource and its major elements. Include design, materials, condition, alterations, size, setting, and boundaries.)
The one-story Ranch style building is 'L'-shaped in plan. The gable on hipped roof, with boxed eaves, is clad in composition shingles. The gables are accented with lattice-patterned false timbering. The exterior walls are clad in smooth textured stucco and stone veneer. The aluminum sliding and fixed-pane windows appear to be original. The primary entrance is recessed and at grade. An attached two-car garage projects from the northern end of the primary (eastern) façade. The eastern façade of the garage is accented with fixed-pane windows with pebble glass and false timbering. A weathervane further accents the gable. Landscaping includes a mature eucalyptus tree in the parkway and stone planters. The building does not meet the NRHP and CRHR eligibility criteria for the reasons identified on the district record prepared for this subdivision; therefore the building does not contribute to a historic district and is not individually eligible for listing in the NRHP and the CRHR.

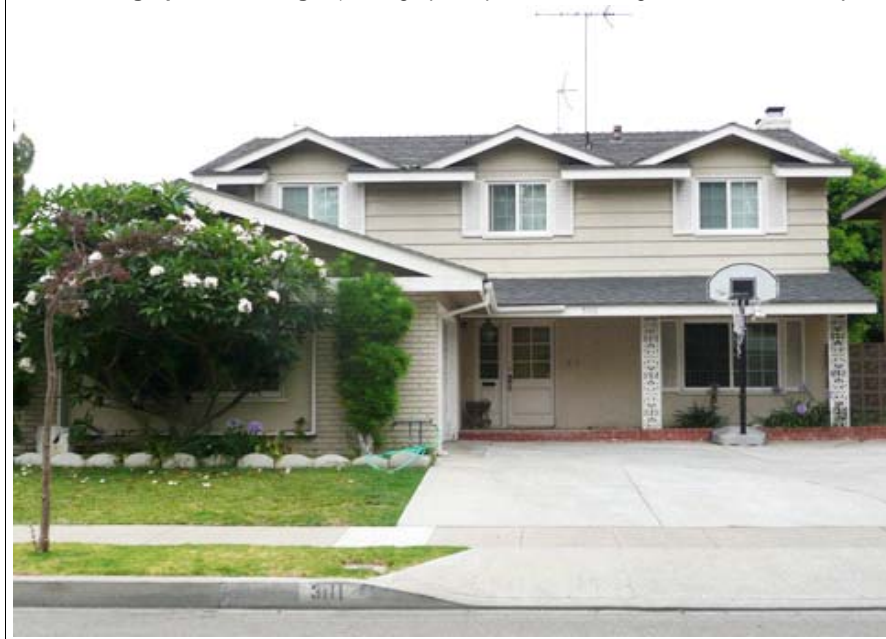
Facing west; 7/8/2010; Photo No.

* P3a. Description: (Describe resource and its major elements. Include design, materials, condition, alterations, size, setting, and boundaries.)
The two-story Ranch style building is 'L'-shaped in plan. The cross gabled roof, with boxed eaves, is clad in composition shingles. A brick chimney is centrally located on the northern elevation. The exterior walls are clad in smooth textured stucco, horizontal wood siding on the upper floor, and brick veneer on the eastern façade of the projecting garage. The windows have been replaced with vinyl sliding units, and are accented with wood surrounds and shutters. The primary entrance is raised and accessed via a brick-clad porch. The pent porch roof is supported by decorative metal columns. The primary entry door is wood with pebble glass lights with matching sidelight. The building does not meet the NRHP and CRHR eligibility criteria for the reasons identified on the district record prepared for this subdivision; therefore the building does not contribute to a historic district and is not individually eligible for listing in the NRHP and the CRHR.

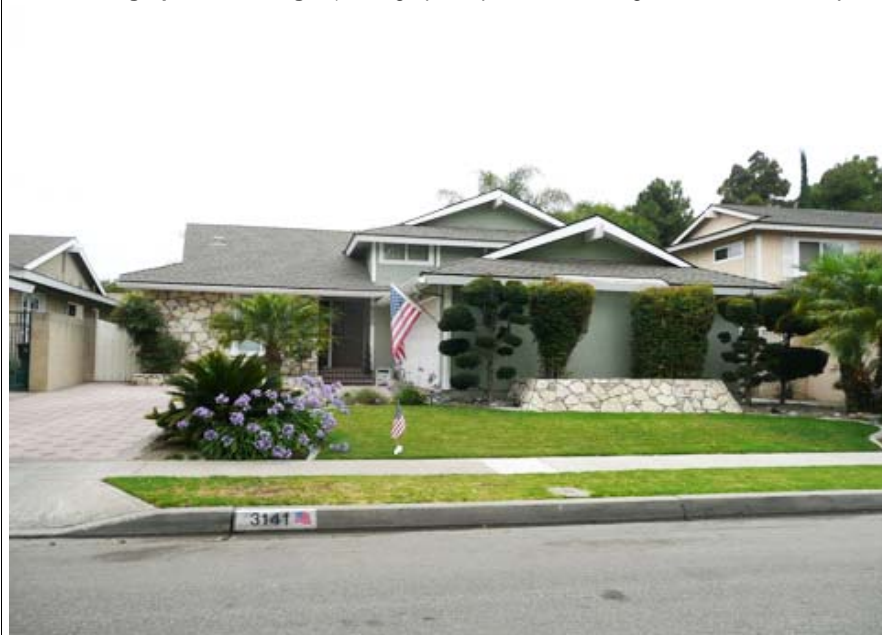
Facing west; 7/8/2010; Photo No.

* P3a. Description: (Describe resource and its major elements. Include design, materials, condition, alterations, size, setting, and boundaries.)
The 1 1/2-story Ranch style building is 'L'-shaped in plan. The gable on hip roof, with boxed flared eaves, is clad in composition shingles. The apexes of the gables are accented with false beams. The exterior walls are clad in smooth textured stucco, vertical wood siding, and stone veneer. The windows have been replaced with vinyl sliding units, and are accented with wood surrounds. The primary entrance is raised, recessed, and accessed via a brick-clad porch. An attached two-car garage projects from the northern end of the primary (northern) façade. Landscaping includes stone planters and topiaries. The building does not meet the NRHP and CRHR eligibility criteria for the reasons identified on the district record prepared for this subdivision; therefore the building does not contribute to a historic district and is not individually eligible for listing in the NRHP and the CRHR.

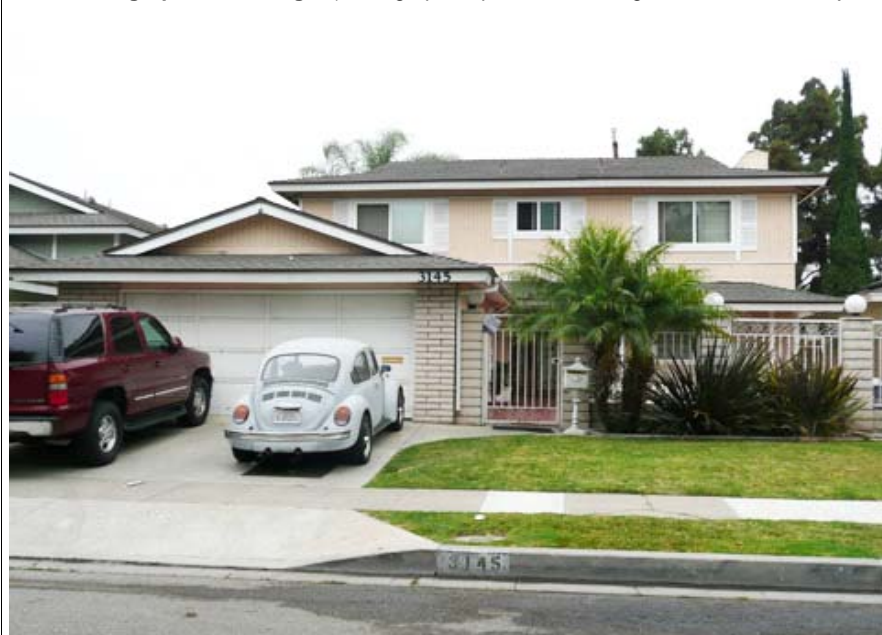
Facing west; 7/8/2010; Photo No.

* P3a. Description: (Describe resource and its major elements. Include design, materials, condition, alterations, size, setting, and boundaries.)
The two-story Ranch style building is 'L'-shaped in plan. The gable on hip roof, with boxed eaves, is clad in composition shingles. A brick chimney is centrally located on the north elevation. The exterior walls are clad in smooth textured stucco and vertical wood siding on the upper floor, and the garage entrance is further accented with brick veneer. The windows have been replaced with vinyl sliding units, and are accented with shutters. False timbering encloses the ribbon of windows on the second floor. The primary entrance is raised and accessed via an enclosed courtyard. The courtyard is enclosed with a metal fence with brick piers with globe lights. The building does not meet the NRHP and CRHR eligibility criteria for the reasons identified on the district record prepared for this subdivision; therefore the building does not contribute to a historic district and is not individually eligible for listing in the NRHP and the CRHR.

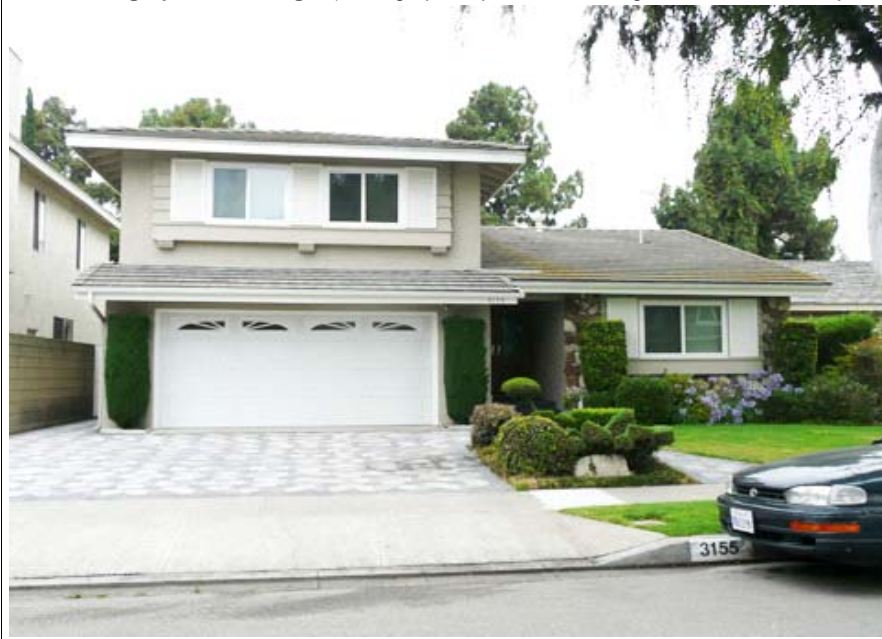
Facing west; 7/8/2010; Photo No.

* P3a. Description: (Describe resource and its major elements. Include design, materials, condition, alterations, size, setting, and boundaries.)
The 1 1/2-story Ranch style building is 'L'-shaped in plan. The pyramid and side gabled roofs, with boxed eaves, are clad in composition shingles. A brick chimney is located on the northern elevation. The exterior walls are clad in textured stucco and stone veneer. The windows on the primary (eastern) façade are located in small projecting bays with horizontal wood siding and corbels. The windows have been replaced with vinyl sliding units, and are further accented with shutters. The primary entrance is raised, recessed, and accessed via a brick-clad porch. The building does not meet the NRHP and CRHR eligibility criteria for the reasons identified on the district record prepared for this subdivision; therefore the building does not contribute to a historic district and is not individually eligible for listing in the NRHP and the CRHR.

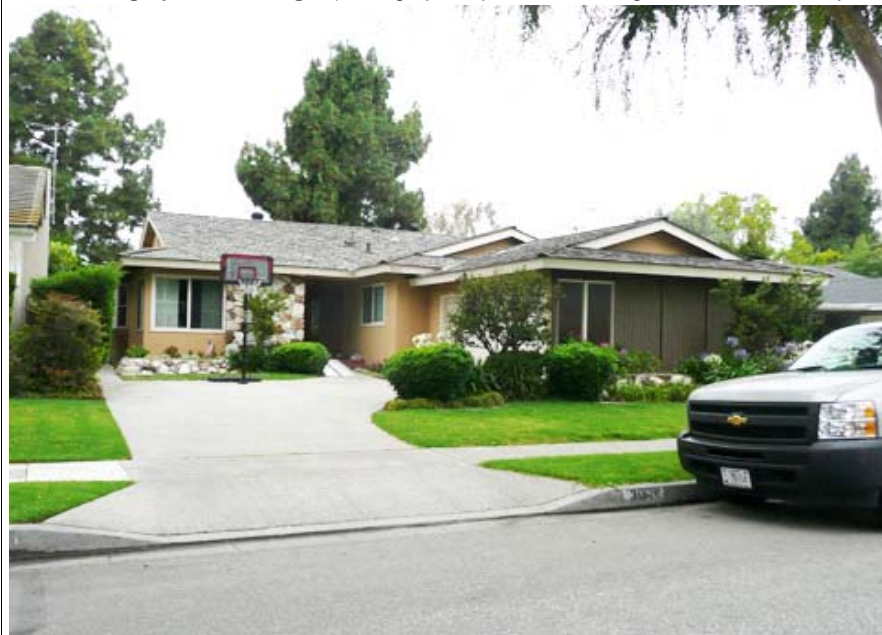
Facing west; 7/8/2010; Photo No.

* P3a. Description: (Describe resource and its major elements. Include design, materials, condition, alterations, size, setting, and boundaries.)
The one-story Ranch style building is 'L'-shaped in plan. The cross gable on hip roof, with boxed eaves, is clad in composition shingles. The exterior walls are clad in smooth textured stucco and vertical wood siding. The windows have been replaced with vinyl sliding units, and are accented with wood surrounds. The sliding window in the garage is accented with pebble glass. The primary entrance is raised, recessed, and accessed via a tile-clad porch. Paired orb lights accent the entryway. An attached two-car garage projects from the northern end of the primary (eastern) façade. Landscaping includes stone planters and a mature eucalyptus tree in the parkway. The building does not meet the NRHP and CRHR eligibility criteria for the reasons identified on the district record prepared for this subdivision; therefore the building does not contribute to a historic district and is not individually eligible for listing in the NRHP and the CRHR.

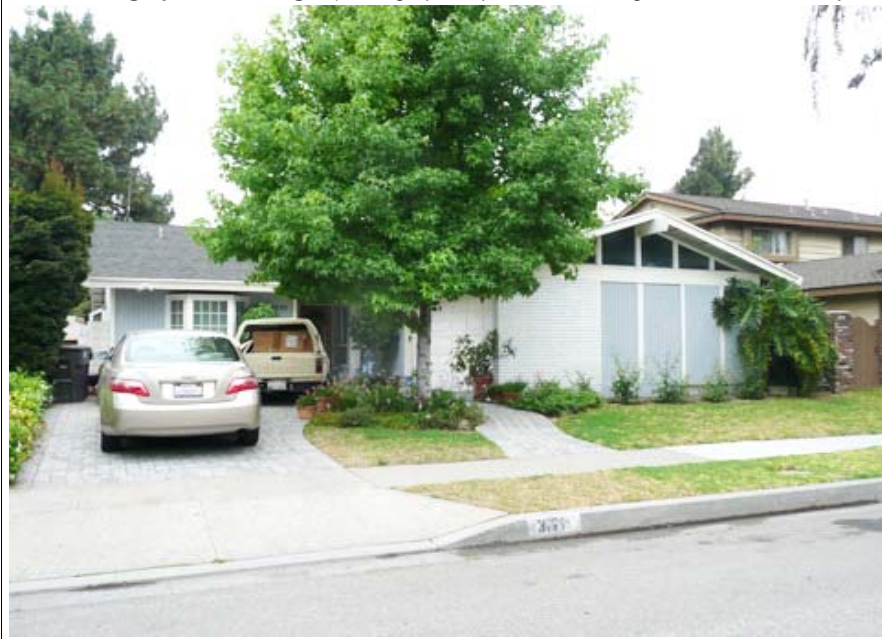
Facing west; 7/8/2010; Photo No.

* P3a. Description: (Describe resource and its major elements. Include design, materials, condition, alterations, size, setting, and boundaries.)
The one-story Ranch style building is 'L'-shaped in plan. The cross gabled roof, with boxed eaves, is clad in composition shingles. The exterior walls are clad in vertical wood siding and brick veneer. A canted bay, with vinyl fixed-pane and casement windows is centrally located on the southern bay of the primary (eastern) façade. Other windows have been replaced with vinyl sliding units. The primary entrance is recessed and is at grade. An attached two-car garage projects from the northern end of the primary (eastern) façade. The gable on the eastern façade of the garage is accented with a fixed-pane transom with band board, and false board at the apex of the gable. The building does not meet the NRHP and CRHR eligibility criteria for the reasons identified on the district record prepared for this subdivision; therefore the building does not contribute to a historic district and is not individually eligible for listing in the NRHP and the CRHR.

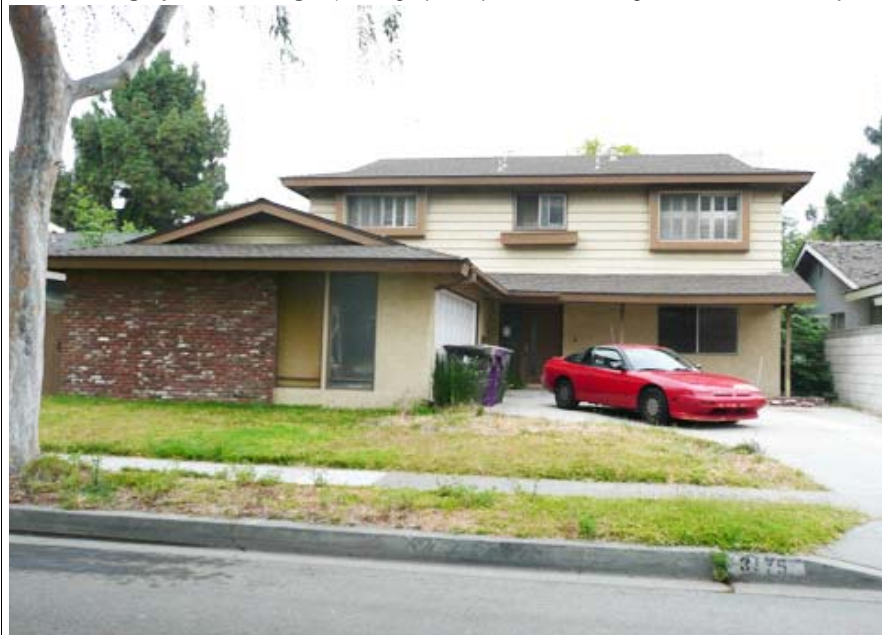
P5b. Description of Photo: (View, date, etc.)
Facing west; Photo No. P1040518; 7/8/2010

* P3a. Description: (Describe resource and its major elements. Include design, materials, condition, alterations, size, setting, and boundaries.)
The two-story Ranch style building is 'L'-shaped in plan. The gable on hip, with flared eaves, roof is clad in composition shingles. The exterior walls are clad in smooth textured stucco and horizontal wood siding. A brick chimney is located on the northern façade. The projecting garage is accented with brick veneer. The aluminum sliding windows appear to be original, and are accented with exaggerated wood surrounds or flower boxes. The primary entrance is raised, recessed, and accessed via a covered porch which partially spans the primary façade. The porch roof is supported by simple square posts. The primary entrance is characterized by a wood door with fritted glass sidelight. A garage projects from the southern end of the primary façade, and is further accented with two fixed-pane windows with pebble glass. The building does not meet the NRHP and CRHR eligibility criteria for the reasons identified on the district record prepared for this subdivision; therefore the building does not contribute to a historic district and is not individually eligible for listing in the NRHP and the CRHR.

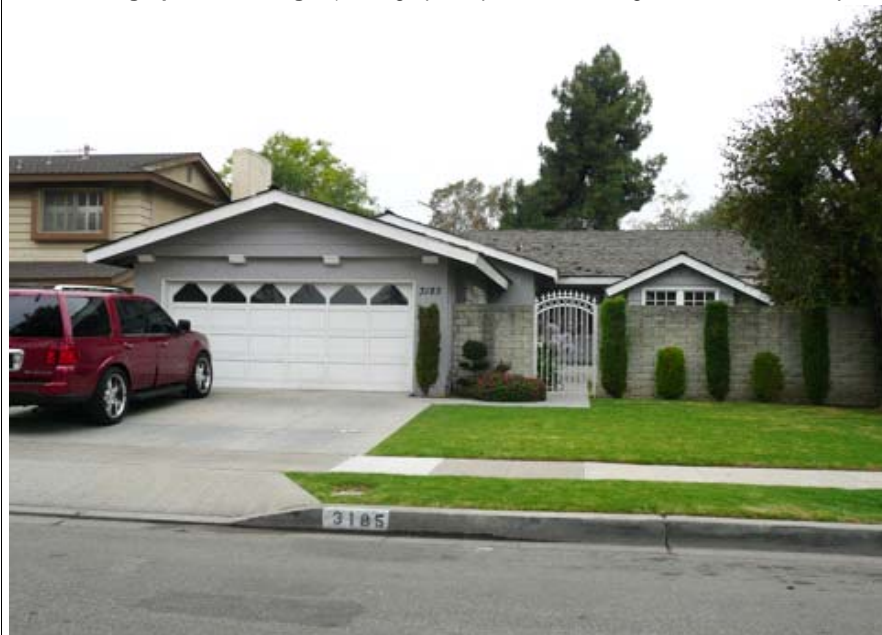
Facing west; 7/8/2010; Photo No.

* P3a. Description: (Describe resource and its major elements. Include design, materials, condition, alterations, size, setting, and boundaries.)
The one-story Ranch style building is 'L'-shaped in plan. The cross gabled roof, with boxed eaves, is clad in wood shingles. The exterior walls are clad in smooth textured stucco and stone veneer. The windows on the primary (eastern) façade are located in projecting bays clad in horizontal wood siding with corbel accents. The northern bay is further accented with a doveote, and the gable is asymmetric with the northerly eave extending lower than the southerly eave. The six-over-six wood sash and diamond-pane windows appear to be original. The primary entrance is raised, recessed, and accessed via a tiled porch. An attached two-car garage projects from the southern end of the primary (eastern) façade, and is accented with horizontal wood siding and corbels. The front courtyard is enclosed with a brick fence with metal gate. The building does not meet the NRHP and CRHR eligibility criteria for the reasons identified on the district record prepared for this subdivision; therefore the building does not contribute to a historic district and is not individually eligible for listing in the NRHP and the CRHR.

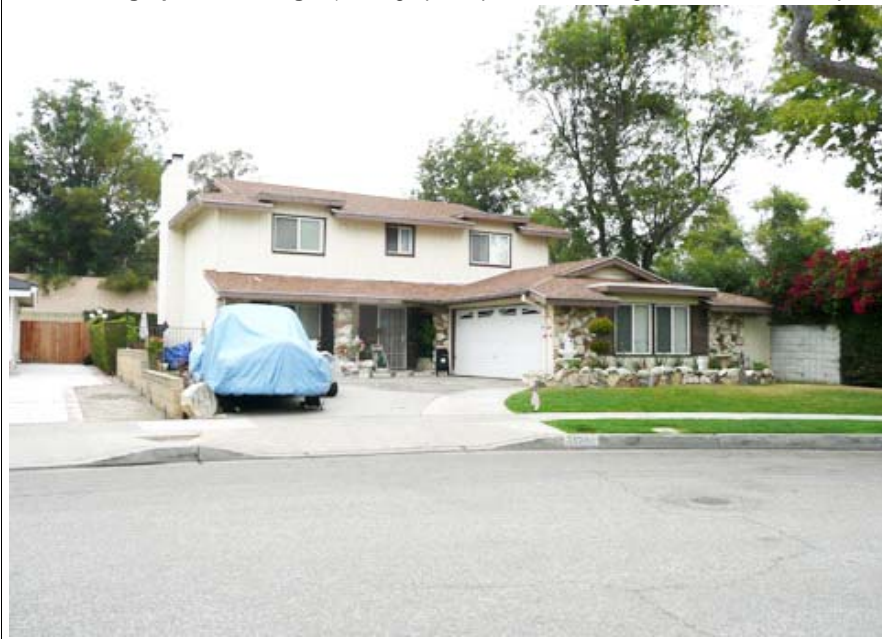
Facing northwest; 7/8/2010; Photo No.

* P3a. Description: (Describe resource and its major elements. Include design, materials, condition, alterations, size, setting, and boundaries.)
The two-story Ranch style building is 'L'-shaped in plan. The gable on hip roof, with boxes eaves, is clad in composition shingles. The gables are accented with low-sloped pent roofs. A brick chimney is located on the southern elevation. The exterior walls are clad in vertical wood siding, textured stucco, and stone veneer. The modern aluminum sliding windows are accented with wood surrounds and shutters on the ground floor. The primary entrance is raised, and accessed via a covered porch. The porch roof is supported by stone-clad piers. An attached two-car garage projects from the northern end of the primary (eastern) façade. Landscaping includes stone planters, and a concrete block wall demarcates the front and rear yards. The building does not meet the NRHP and CRHR eligibility criteria for the reasons identified on the district record prepared for this subdivision; therefore the building does not contribute to a historic district and is not individually eligible for listing in the NRHP and the CRHR.
